# EARTHQUAKES AND THE RBC MUSEUM EXPANSION

## Major Earthquakes and The Renovation and Expansion of the Royal BC Museum

ESMS 4900 – 18WI BESMS Capstone

Justice Institute of British Columbia

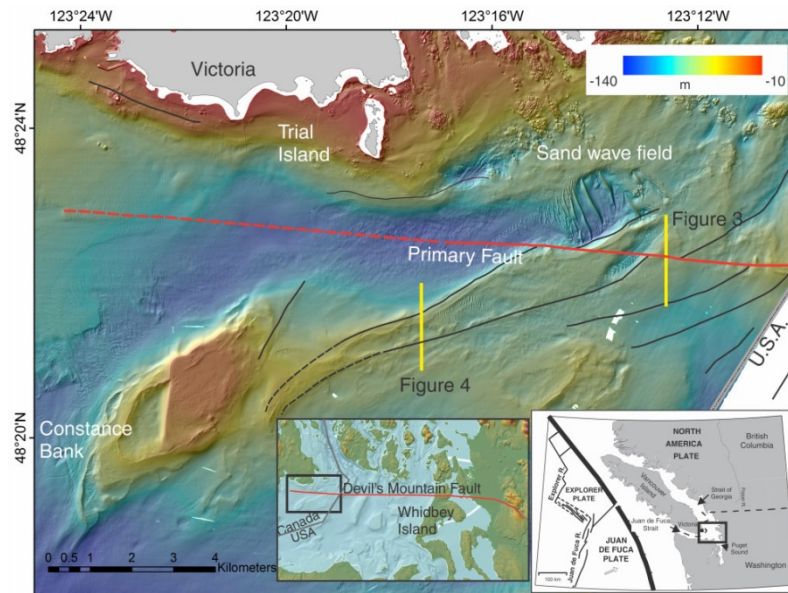
From this data Barrie was able to create a 3D map displaying a short section of the Devil's Mountain Fault Zone (represented in red on the map inset below), establishing it as a deep crack in the Earth's crust that runs for about 125 kilometers from near Darrington in the foothills of the Cascade Mountains in Washington, to just south of Victoria.

*Figure 1:* The Devil's Mountain Faults, indicated here by a red line, is actually made up of a series of faults that run from Washington to Victoria. Reprinted from Ministry of Natural Resources, Government of Canada <https://www.canada.ca/en.html>

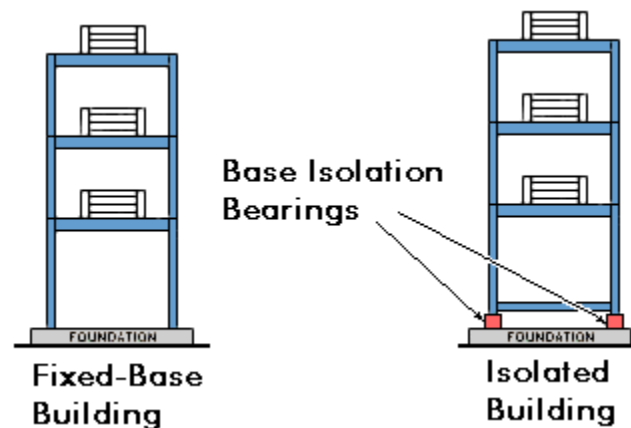
Isolation and Energy Dissipation devices (Bhandari, et al, 2016, p. 2). For the museum towers, a base isolated structure would be supported by a series of bearing pads which are placed between the building and the foundation, with the bearing being very stiff and strong in the vertical direction, but flexible in the horizontal direction, as shown in Figure 1.

*Figure 1: Base-Isolated and Fixed-Base Buildings. Reprinted from Earthquake Resistant Design Techniques for Buildings and Structures. Retrieved from <https://theconstructor.org/earthquake/earthquake-resistant-techniques/5607/>*

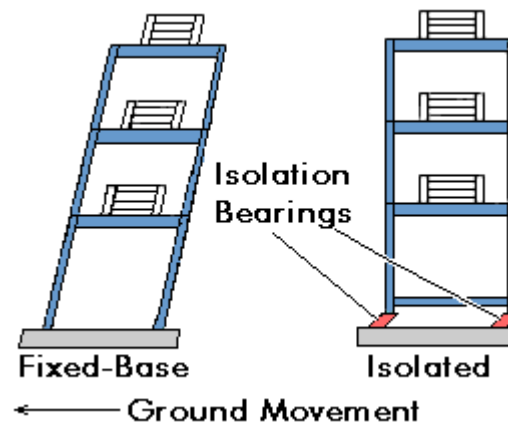
In the event of an earthquake, the ground beneath each building begins to move and each building responds with movement which is opposite of the ground motion due to inertia. The inertial forces acting on the towers are the most important of all those generated during an earthquake and are proportional to the building's acceleration during ground motion (Bhandari, et al, 2016. pp. 2-3). The museum's engineers and designers must also note that the towers won't actually shift in only one direction because the complex nature of earthquake ground motion means that the towers will actually tend to vibrate back and forth in varying directions, as seen in Figure 2.

Figure 2: Base-Isolated, Fixed-Base Buildings. Reprinted from Earthquake Resistant Design Techniques for Buildings and Structures. Retrieved from <https://theconstructor.org/earthquake/earthquake-resistant-techniques/5607/>

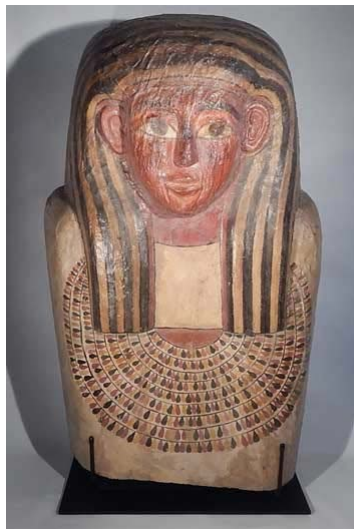
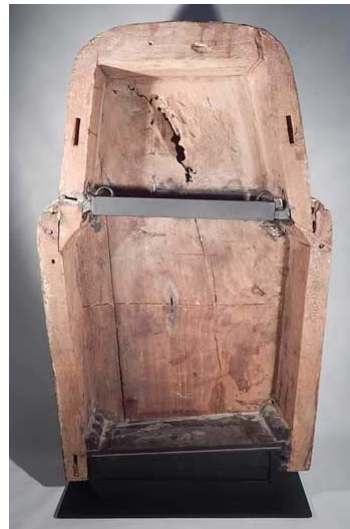
*Figure*

1. Example of a rigid artifact display stand. Weights can be inserted inside the display or in the void below for extra stability. Reprinted from Artifacts Display Stands. Retrieved from <http://ancientartifax.com/stands.htm>

- Lowering an object or object's assembly's center of gravity by adding weight.  
Examples of this are such low-cost items such as placing sand bags inside objects, attaching objects to heavy bases, and adding lead bricks or weights to the inside bottoms of pedestals or cases;
- Restraining objects by firmly securing them to the floor, pedestals, shelves, walls, and/or supporting mounts;
- Use of base isolation methods (p. 8).

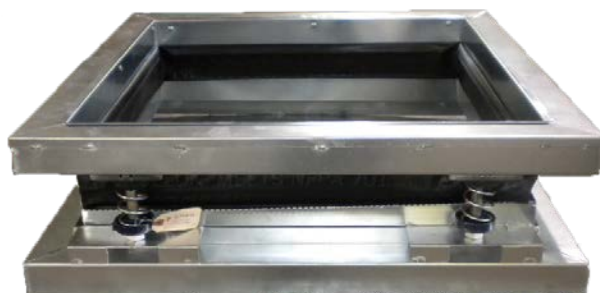
*Figure 2.* Example of a base isolation stand for exhibits. Retrieved from <https://www.bing.com/images/search?view=detailV2&ccid=U7eDC9Ak&id=E18B6E2CA9B6638CDBC3AA117E9E92FB3BFB77CC&thid=OIP.U7eDC9AkI84UAANbwb0TOAHaFj&mediaurl>
